## Interconnection System Impact Study Update Request # GI-2014-7

42 MW Increase to Hydro Pumping Generating Facility Cabin Creek 230 kV Station, Colorado

> Public Service Company of Colorado Transmission Planning March 31, 2015

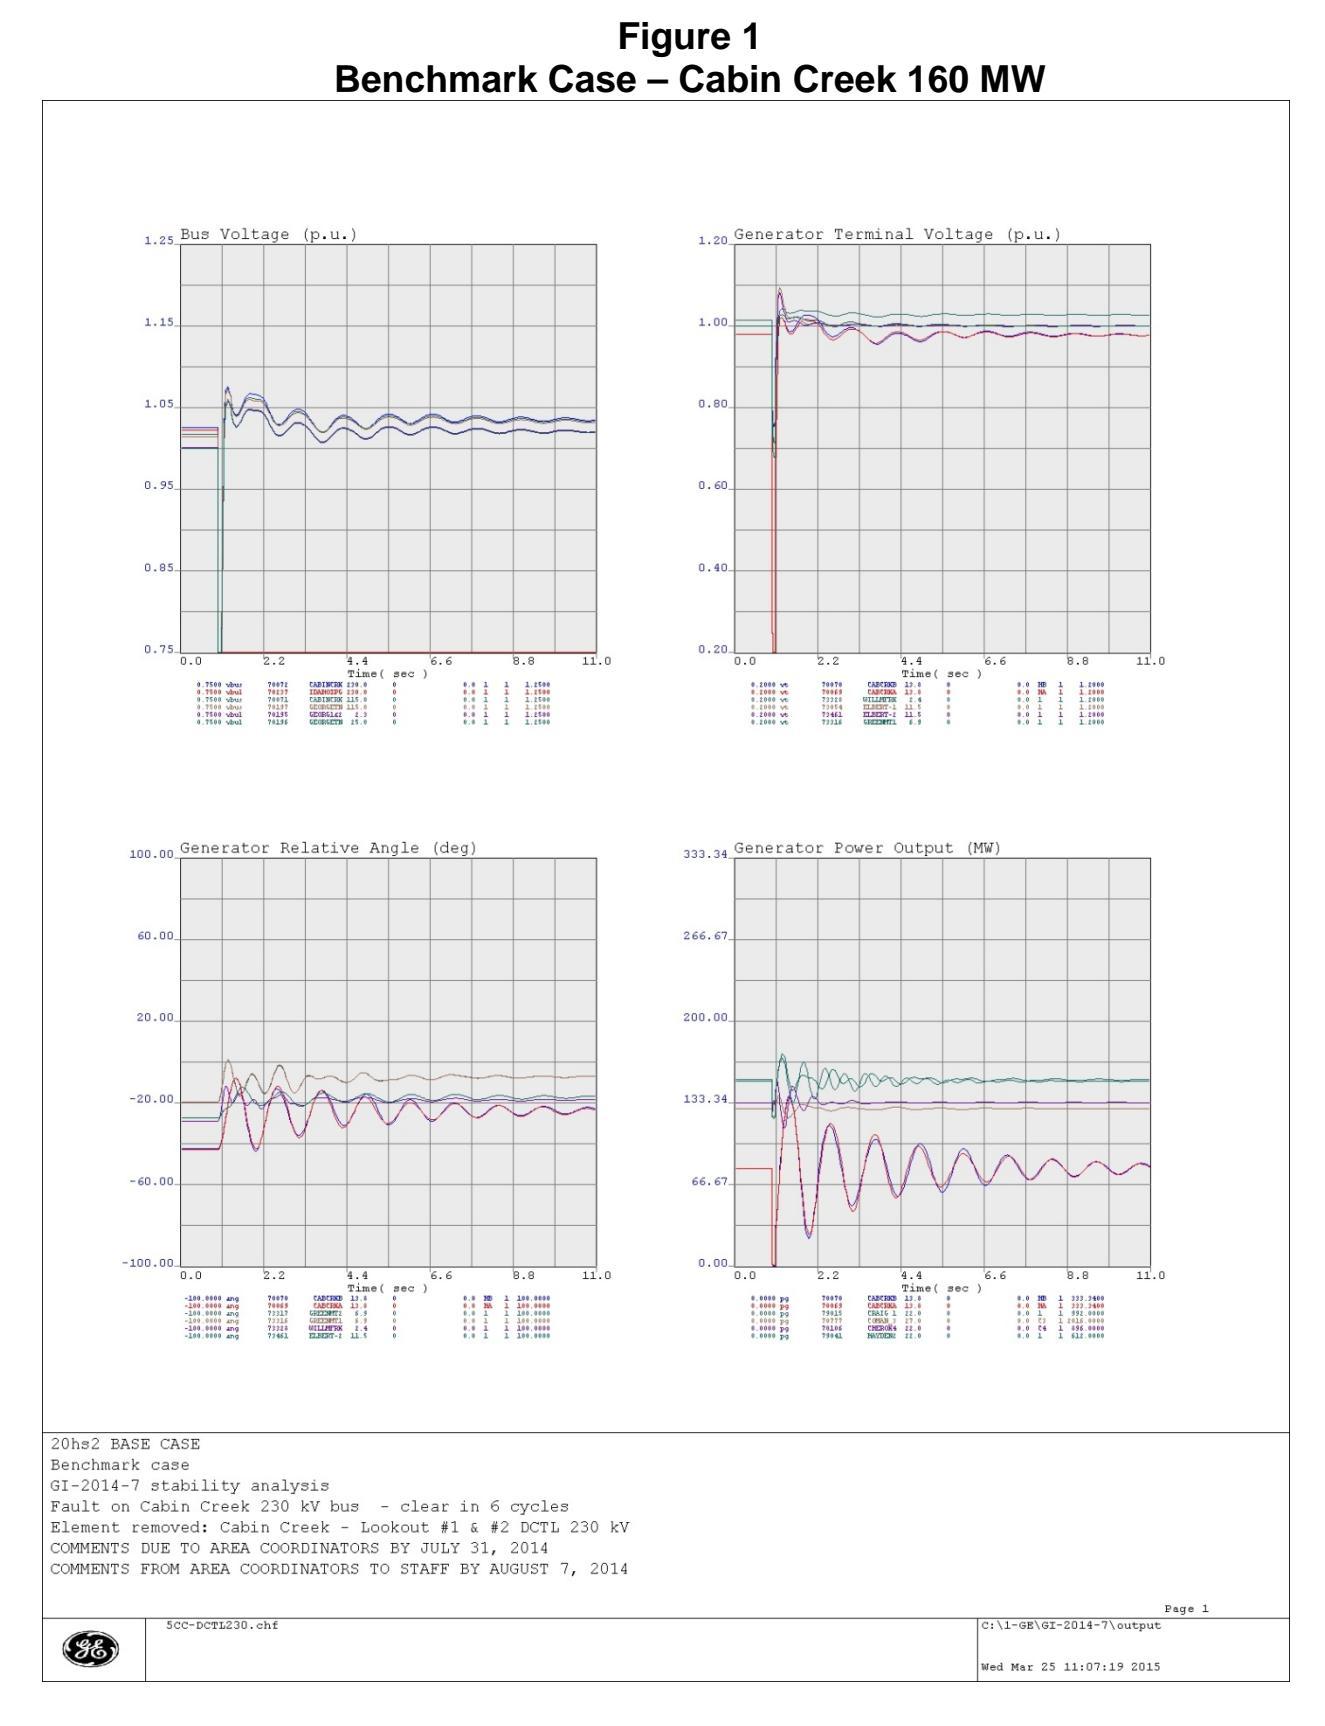
Figure 1 shows the Benchmark case with Cabin Creek at 160 MW output with a well damped oscillation following the loss of the two Cabin Creek-Lookout 230 kV lines. Figure 2 shows the Benchmark case with Cabin Creek at full existing 324 MW output with a slowly damped oscillation.

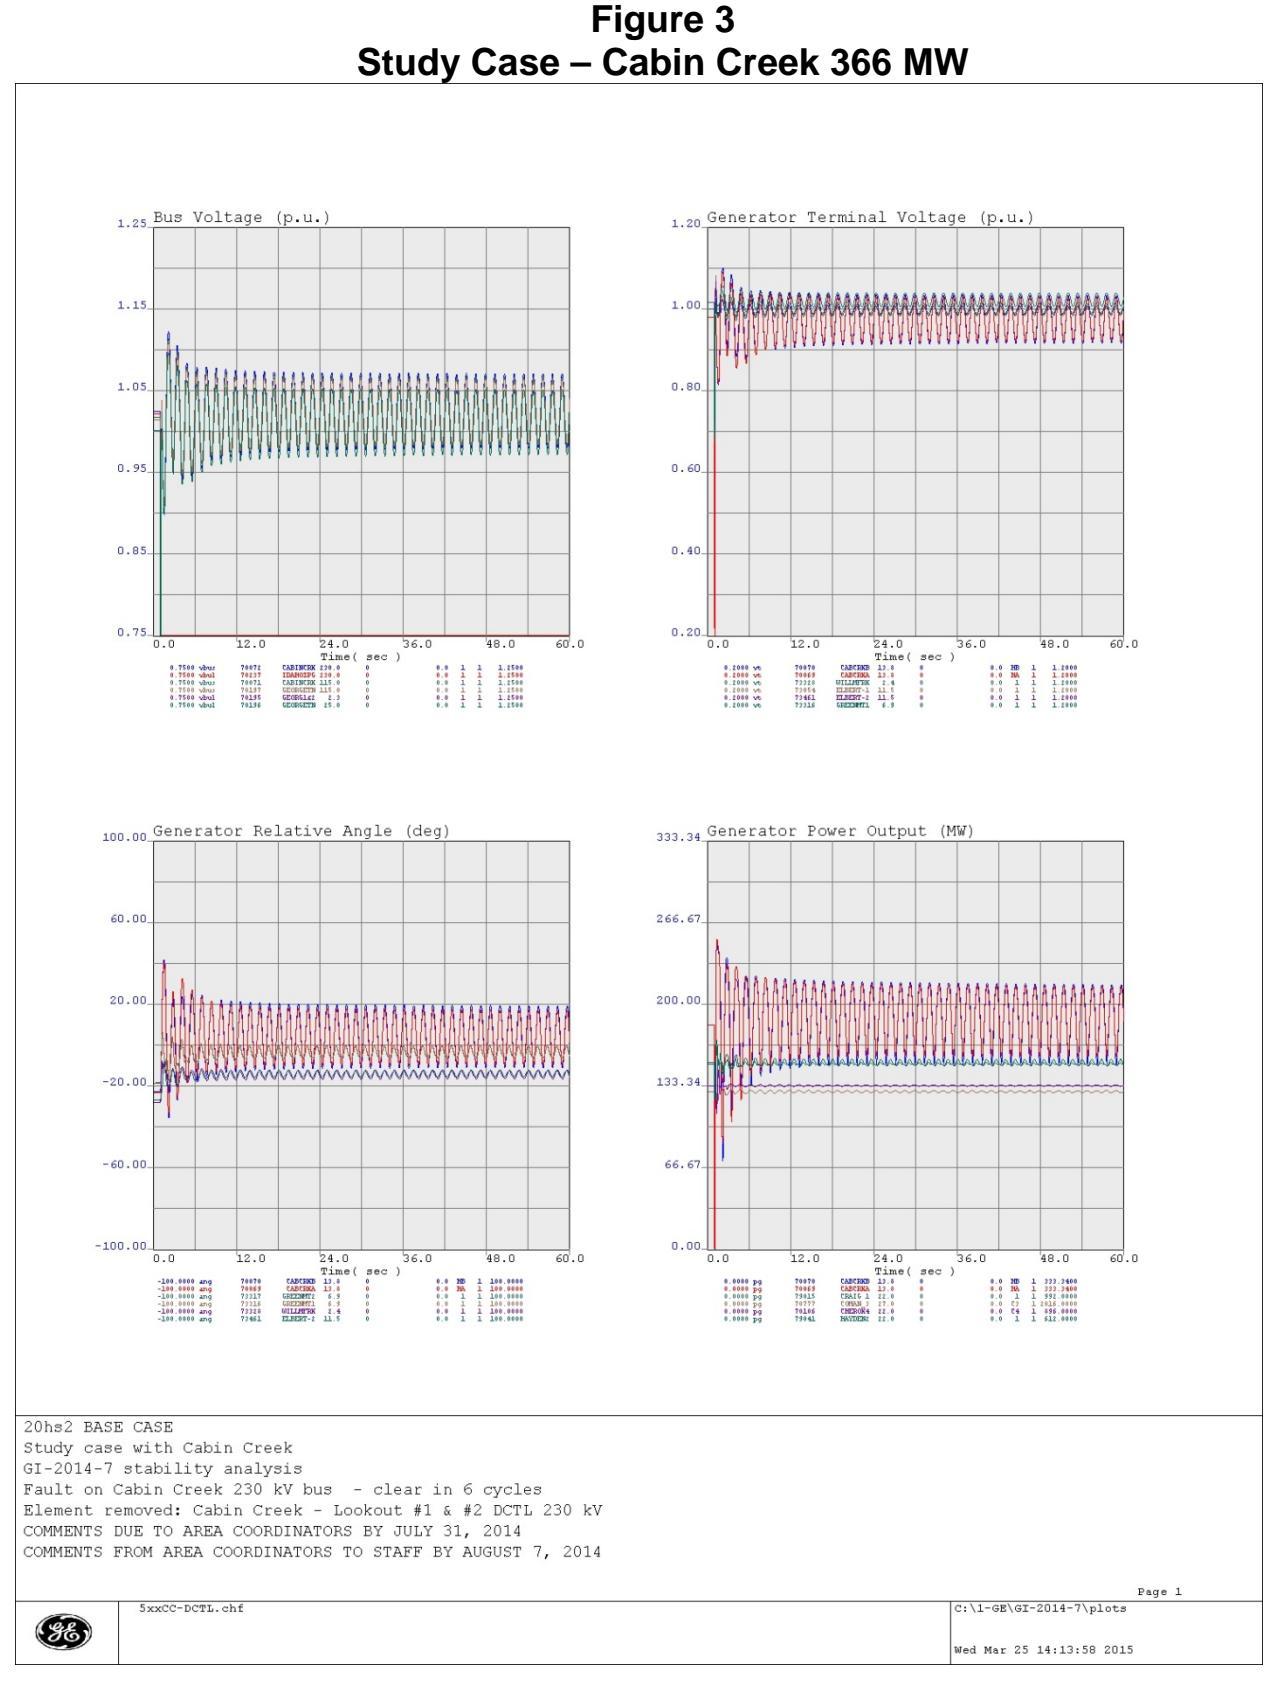
Figure 3 shows the Study case with Cabin Creek at 366 MW output with a continuous oscillation. The observed oscillation is not damped and therefore continues throughout the study time frame of 60 seconds. The NERC Transmission Planning Standard for system performance following loss of two or more elements (TPL-003-0b) states the system must be stable following loss of any two circuits from a multiple circuit tower line.

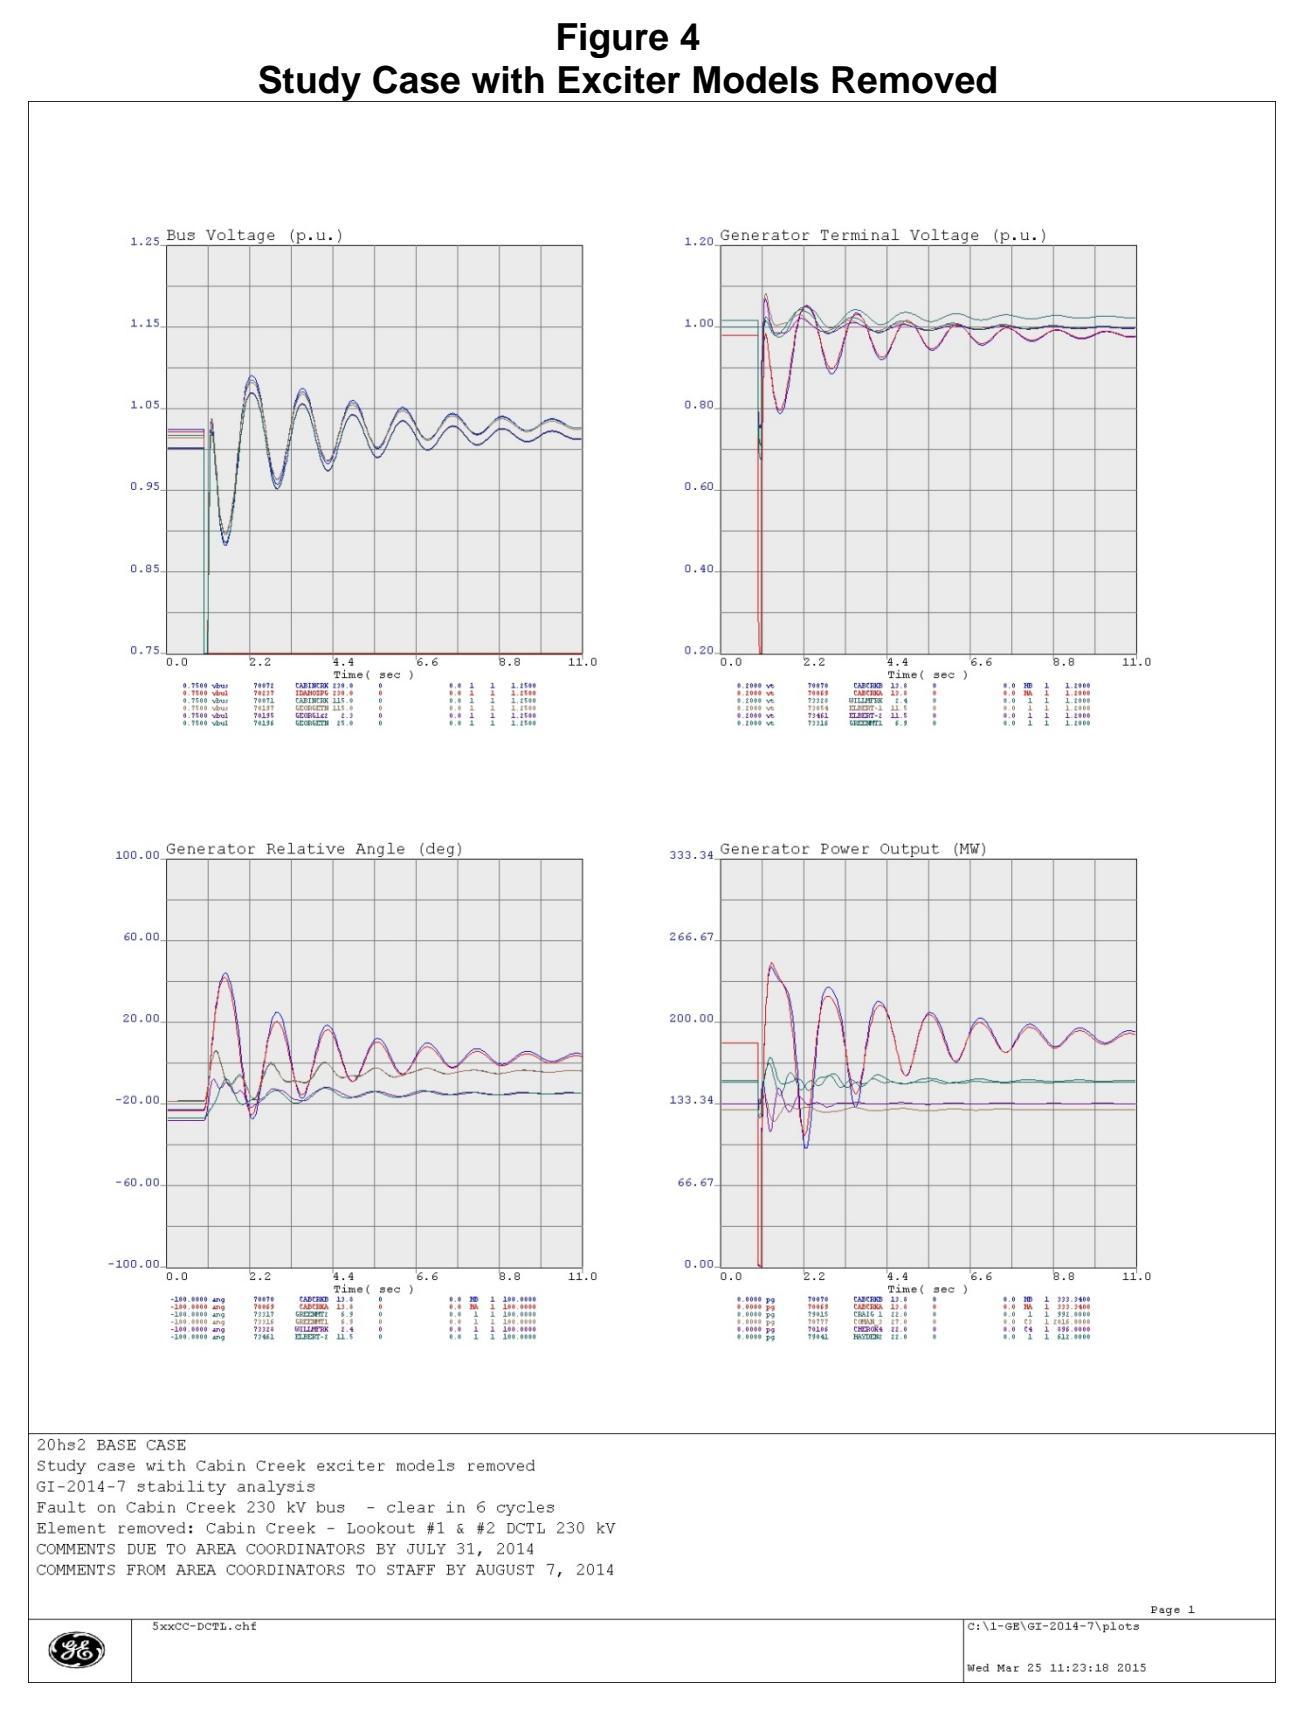
Although the intent of this study does not include isolating the exact cause of the oscillations, an attempt was made to narrow down the issue. In Figure 4 you can see the performance is stable and well damped when the exciter models are removed for both Cabin Creek units. In Figure 5 you can see the oscillation damps very slowly when the power system stabilizers are removed for both units. Hence, the issue may be caused by either model but appears to be more affected by the exciter.
