Signal Hill dynamic stability modeling notes and assumptions

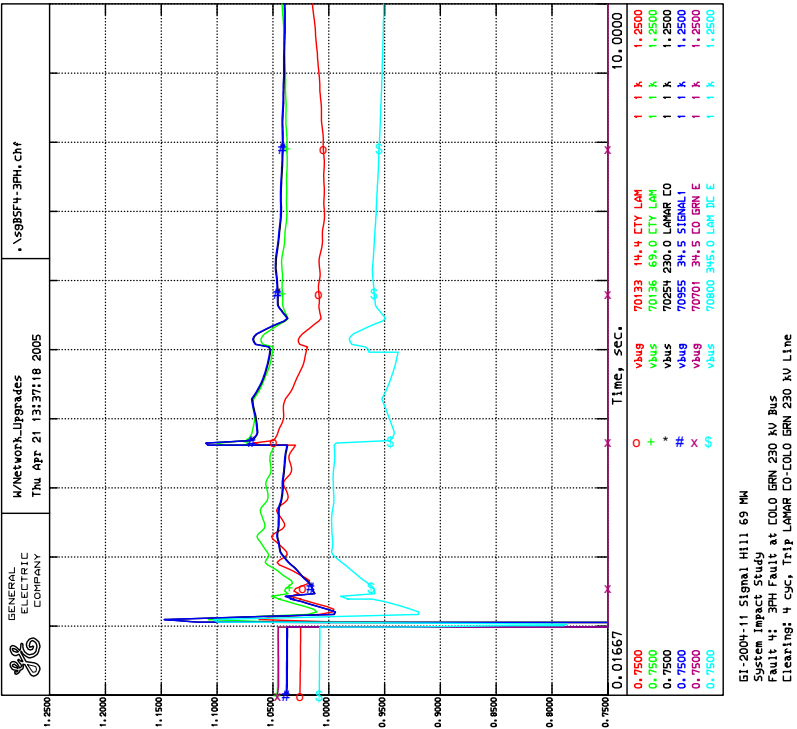
The system was monitored for transient stability violations for each of the fault scenarios. Table 2 summarizes the results of the study. The wind generation tripped offline on undervoltage conditions for the 3-phase faults located on the Lamar and Boone 230 kV buses (Fault 1 and Fault 2). The generation tripped because the voltage at the collector bus dipped to less than 0.3 per-unit voltage.

Voltage and frequency dip violations were observed at Lamar at distribution level voltages for several of the fault cases. These are due to the tripping of the nearby Colorado Green wind turbines, and in the Project cases, the tripping of the Project's wind turbines.

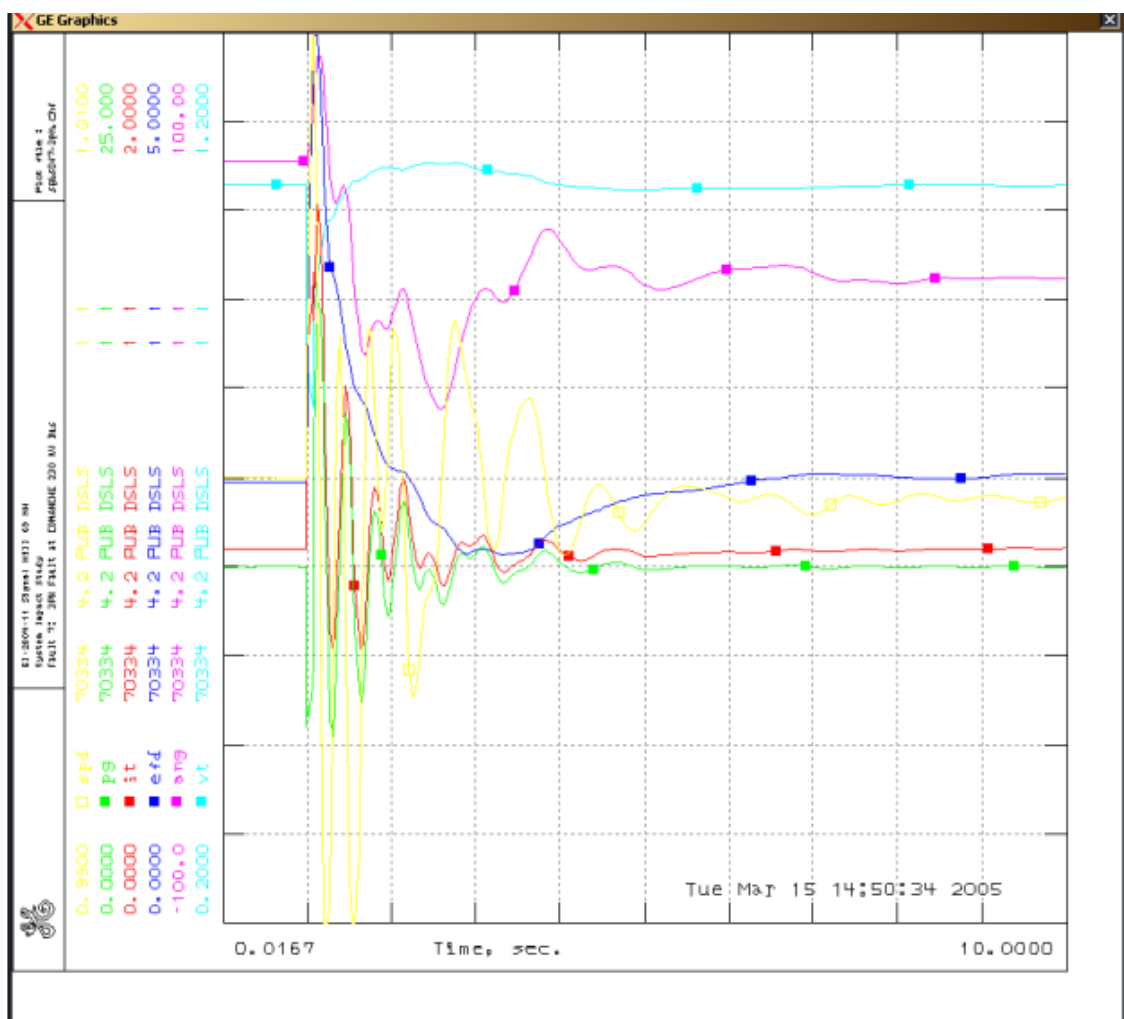
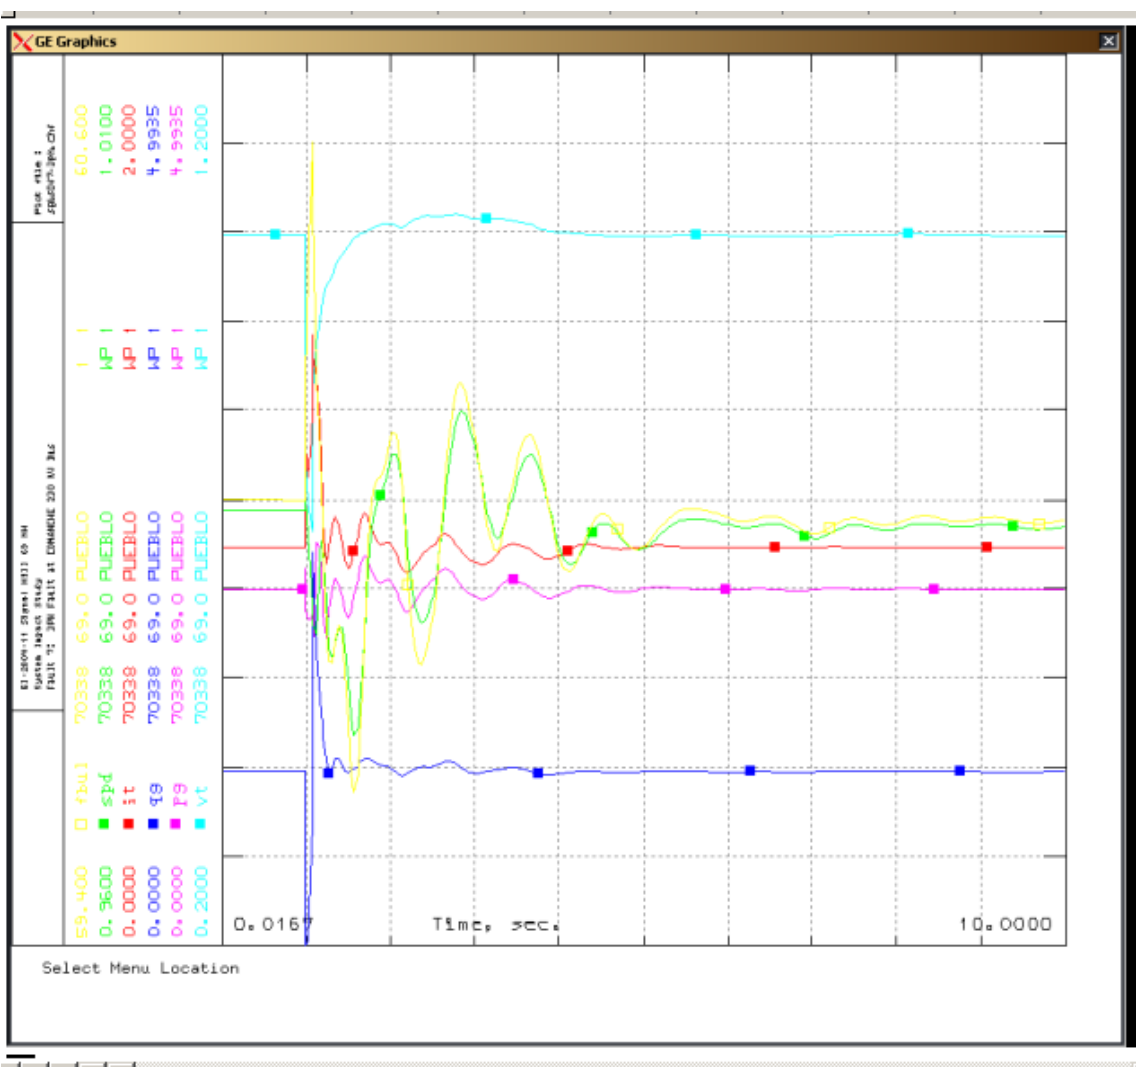
ⁱ Frequency dip is likely due to under-damped model for generator 70334 “PUB DSLS”. May also be due to interactions between 70334 generator and 70338 load “HP.” See plots attached to this footnote.

7	3PH at Comanche Station 230 kV bus; 6 cycles	Trip Comanche Unit 1	System Stable, Colorado Green Wind Tripped, Signal Hill Wind Tripped New frequency violations: • 59.6 Hz for 7 cycles at PUEBLO 69 ⁱ
8	SLG at Boone 230 kV bus; 20 cycles	Trip Boone-Lamar 230 kV line, circuit 2	System Stable
9	SLG at Comanche		
	SLG at Midway 230 kV bus; 20 cycles	Trip Boone-Midway 230 kV line, circuit 2	System Stable
11	SLG at Lamar 230 kV bus; 20 cycles	Trip Boone-Lamar 230 kV line, circuit 2	System Stable
12	3PH at Boone 230 kV bus; 6 cycles	Trip Boone 230-115 kV transformer	System Stable, Colorado Green Wind Tripped; Signal Hill Wind Tripped
